Laboratory Evaluation of Expedient Pavement Repair Materials

Raymond S Rollings

JUNE 1978

FINAL REPORT FOR PERIOD JANUARY 1976-JUNE 1978

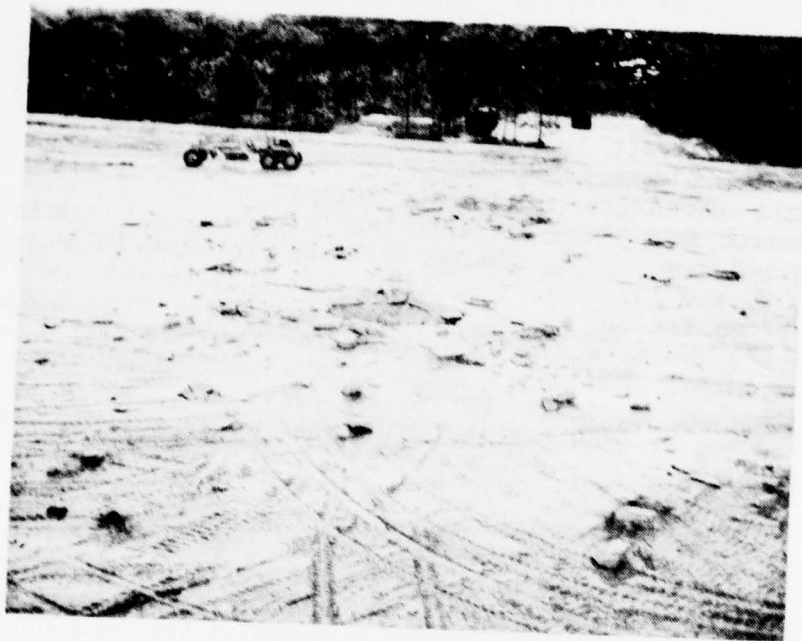
Figure 1. Small Crater, 25 Pound Charge,
Tyndall AFB Field Tests
(Reference 5)
